Date: 31st August, 2010

Affected Products: I-2000 – EWIS Panel

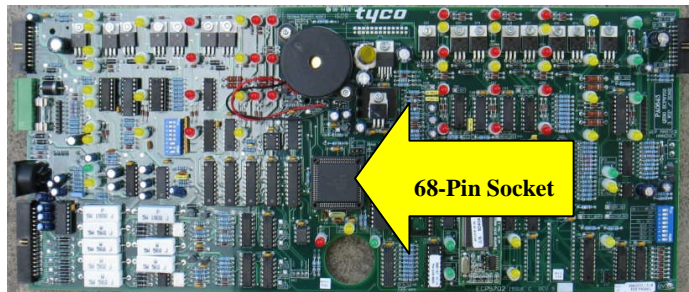
Figure 1 : Location of Microprocessor and 68-pin socket

A small number of recently manufactured I2000 Emergency Control Panels have suffered a momentary processor failure, rebooted, stopped working altogether or might have caused unwanted faults. The affected ECP boards are identified as being manufactured between April 2007 (date code D07) and September 2009 (date code I09) inclusive.

The affected batches of ECP boards are fitted with an unmarked brand of square 68-pin socket which has the microprocessor plugged into it (Figure 1). This socket has been identified as the cause of the problem.

The intermittent re-starting of the microprocessor has been reported to be temporarily fixed by removing, cleaning and re-inserting the microprocessor. This is not considered an adequate long-term fix and is not recommended as the problem may recur.

Any ECP Boards that are in the affected batches (D07 to I09), discovered to have the type of fault mentioned above, should be exchanged through Notifier Inertia.

NOTE: when exchanging the ECP board, the plug-in Integrated Circuit in socket U10 that contains the firmware and site-specific configuration should be carefully removed, and fitted to the replacement ECP board. All link and DIP-switch settings on the new ECP board must be checked and adjusted to match those on the old ECP board. This replacement ECP board should then be fitted to the panel.

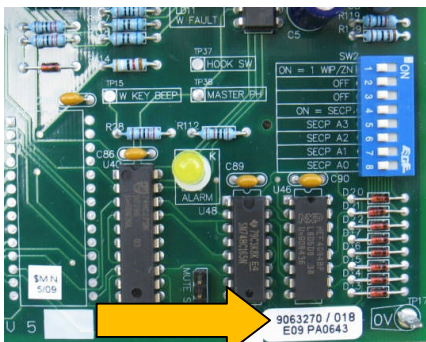
Figure 2 : Location and format of serial number and date code

The location of the serial number and date code is shown by the arrow (9063270 and E09) in Figure 2.

The format of the date code is MYY, where M is the letter A-L for the month (A = January, L = December) and YY is the last two digits of the year, e.g., E09 is May 2009.
